Manhole Inspection Summary

Manhole # S33AA_033MH

Insp Date: **1/19/08 12:59 PM**

Location Address: **815 PARK AVE**

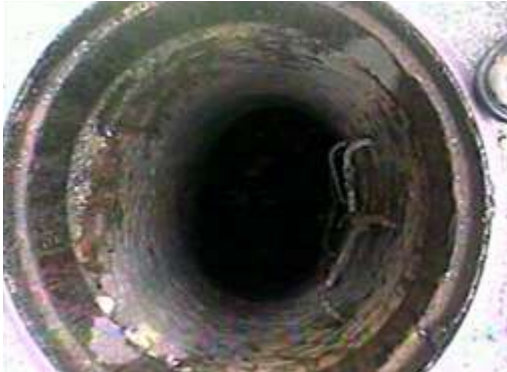
Top View

Offset: **1** (in.)

FRAME OFFSET

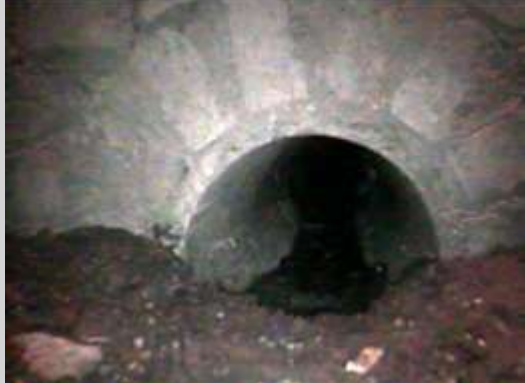
12 O'Clock Outflow

8 in. Circular Gravity Sewer
Pipe Out @ 12 O'Clock

Infiltration: **None** Pipe Seal Cond: **Sound**
